TECHNICAL REPORT HL-89-10

# NAVIGATION CONDITIONS AT GALLIPOLIS LOCKS AND DAM, OHIO RIVER

Hydraulic Model Investigation

Prepared for US Army Engineer District, Huntington  
Huntington, West Virginia 25701-2070

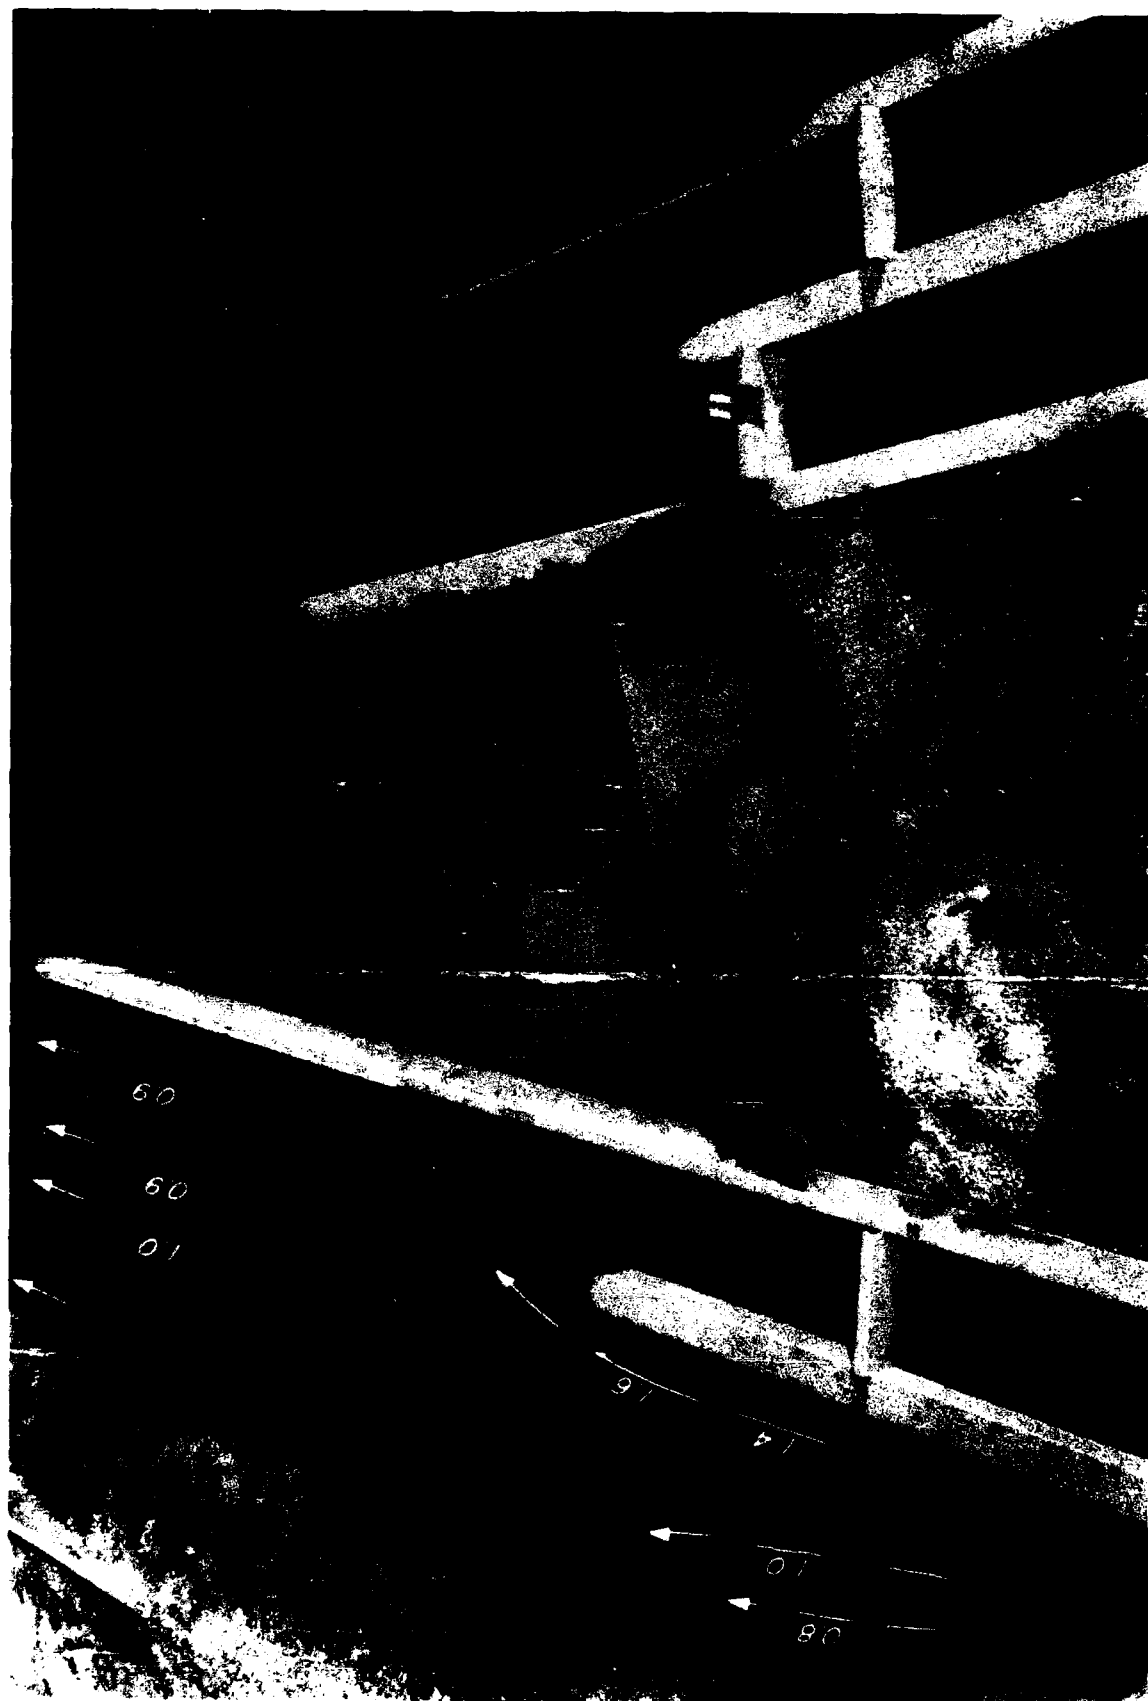
Photo 45. Plan E-7 modified, Scheme 9. No river discharge, upper pool el 538.0, lower pool el 515.0. Surface current and dye patterns during emptying the 600-ft lock in 8 min. Note eddy in approach to existing locks

for conditions to stabilize in the lock approach (stations 4 and 5) was much shorter. The surface current patterns developed during emptying the auxiliary lock (Photo 45) and during emptying both locks simultaneously were about the same as in Scheme 8. Maximum velocities of 1.6 fps obtained in the approach when emptying the auxiliary lock (Photo 46) were slightly greater than with Scheme 8; however, the effects on the tow in the approach to the new locks were about the same. One noticeable difference with this scheme was that if a tow was near the new auxiliary lock entrance during lock emptying, there was a tendency for the tow to be moved toward the center lock wall, then downstream. In Scheme 8, the tow would tend to be moved in a downstream direction only. Navigation conditions in the approach to the existing locks with Schemes 8 and 9 were about the same as with Scheme 7 when emptying the 1,200-ft lock. Observations of tests indicated that with Schemes 8 and 9, conditions would be improved in the approach to the existing locks with flows through the gated spillway.

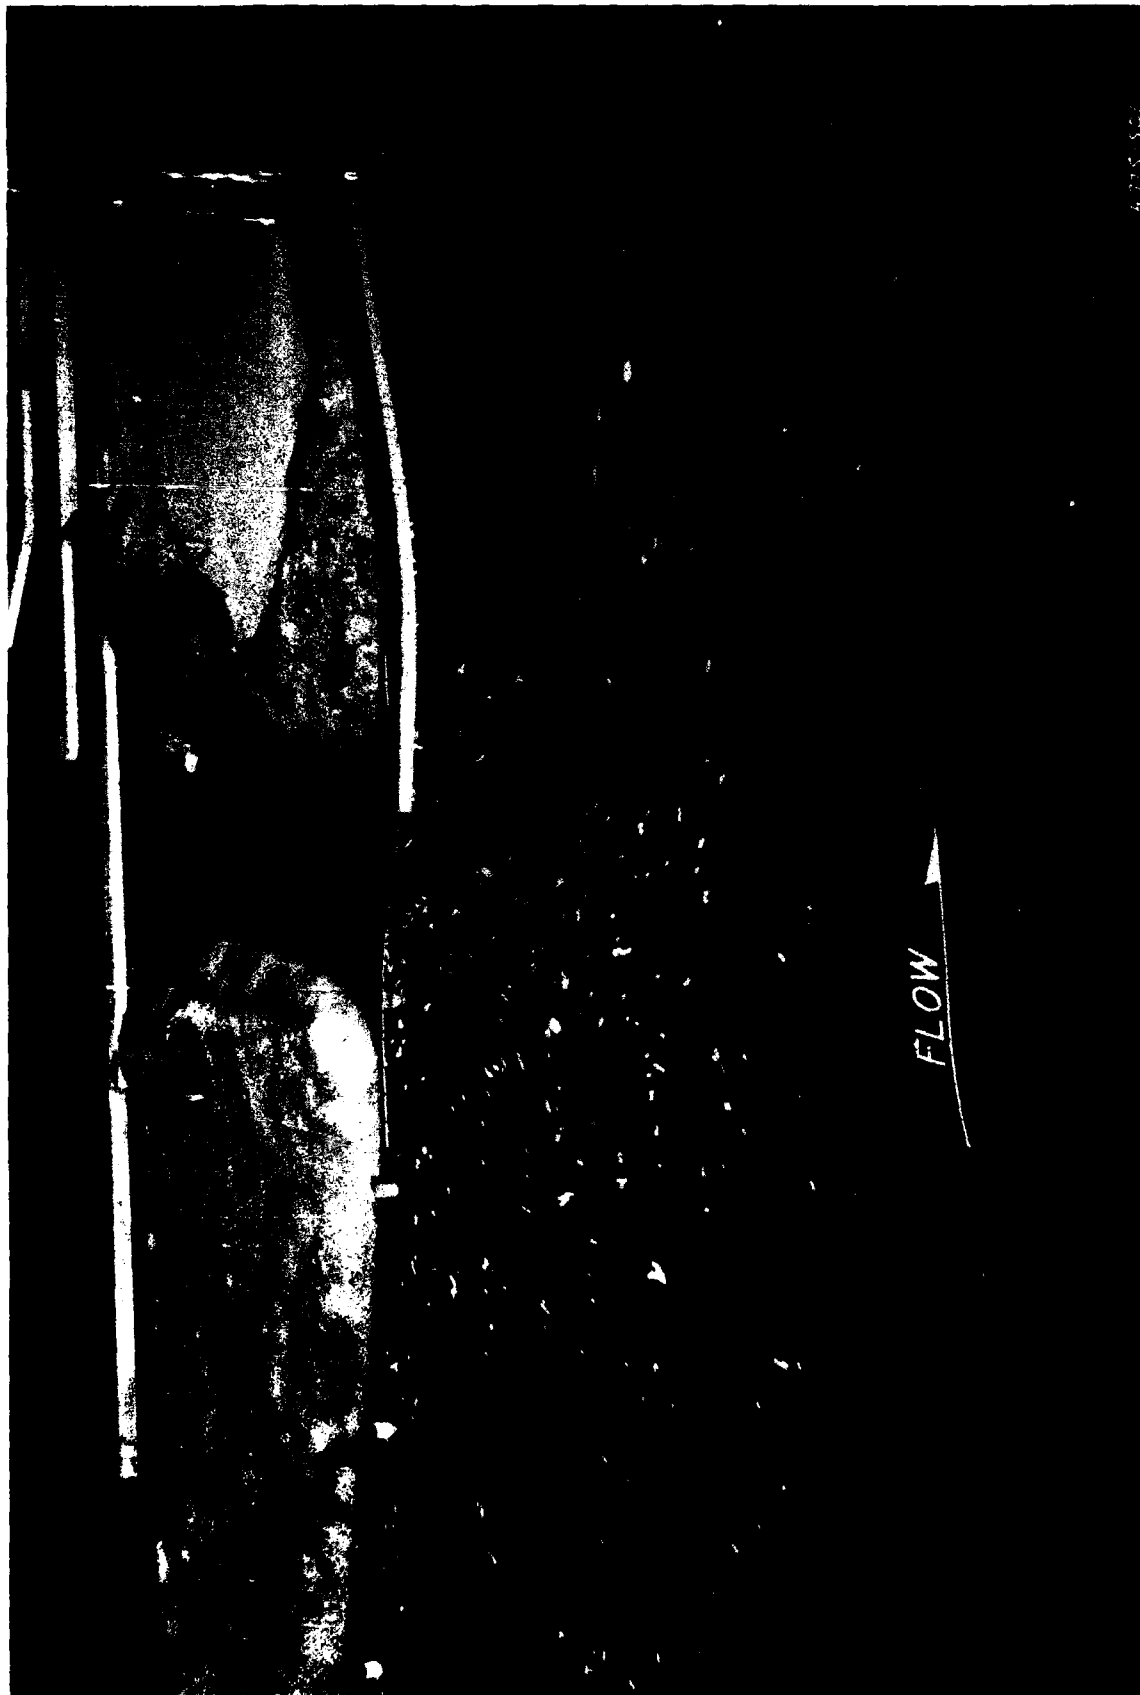
Photo 48. Plan E-10 modified, Scheme 9. Discharge 217,000 cfs, upper pool el 538.0, lower pool el 537.0. Confetti showing the absence of surface current in the approach to the filling intakes resulting from continuous filling of both new locks

(Photo 47). However, as the river discharges were increased, the tendency for sediments, drift, and ice to enter the filling channel from the river was decreased considerably (Photo 48). Some type of barrier could be constructed at the entrance to the filling channel to prevent drift and ice from moving from the river into the filling channel (Photo 49). However, it should be noted that some of the larger pieces of ice or drift could approach the barrier with velocities as great as 2.5 fps (Photo 50).
